**TRANSPORTATION SCIENCES CENTER  
ACCIDENT RESEARCH GROUP**

**CALSPAN ON-SITE AIR BAG DEPLOYMENT INVESTIGATION  
CALSPAN CASE NO. 95-2  
VEHICLE: 1994 FORD F-150 PICKUP TRUCK  
LOCATION: [REDACTED] MS  
CRASH DATE: [REDACTED] 1994**

Contract No. DTNH22-94-D-07058

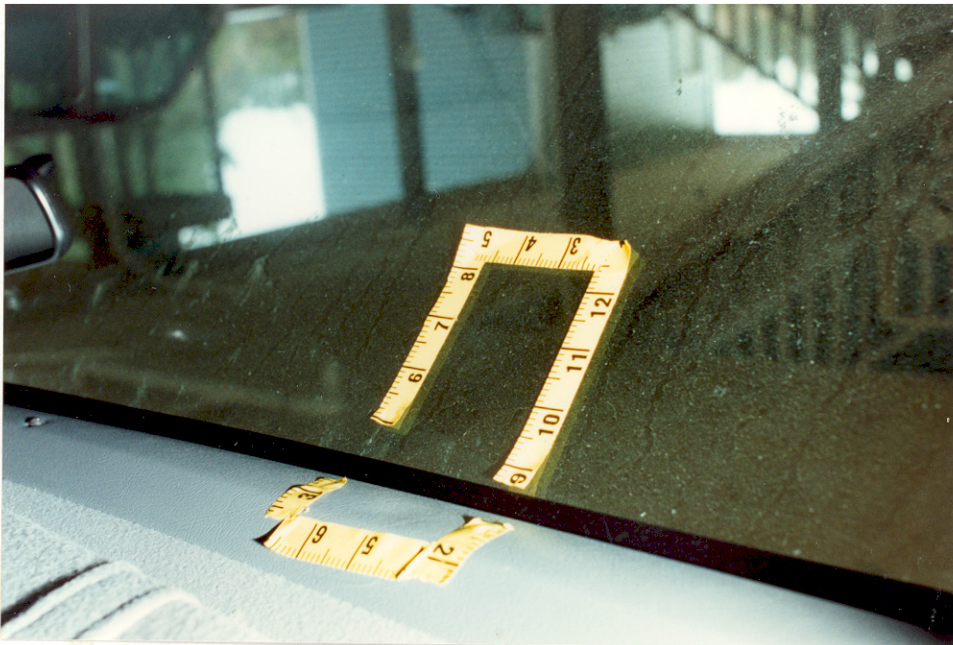
38. Close-up view of the head contacts.

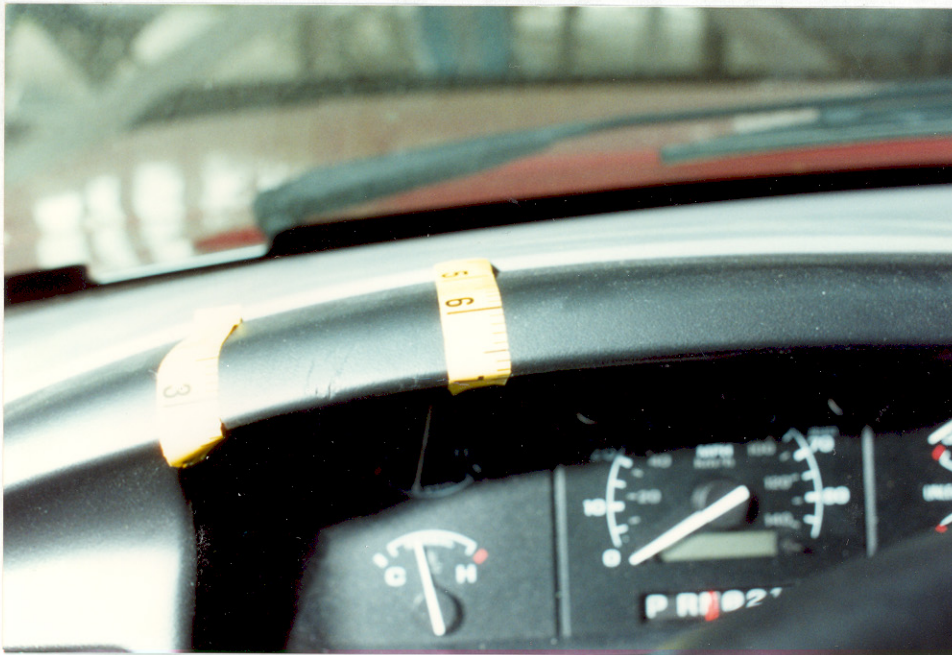
39. Probable contact from the separated upper module cover flap.

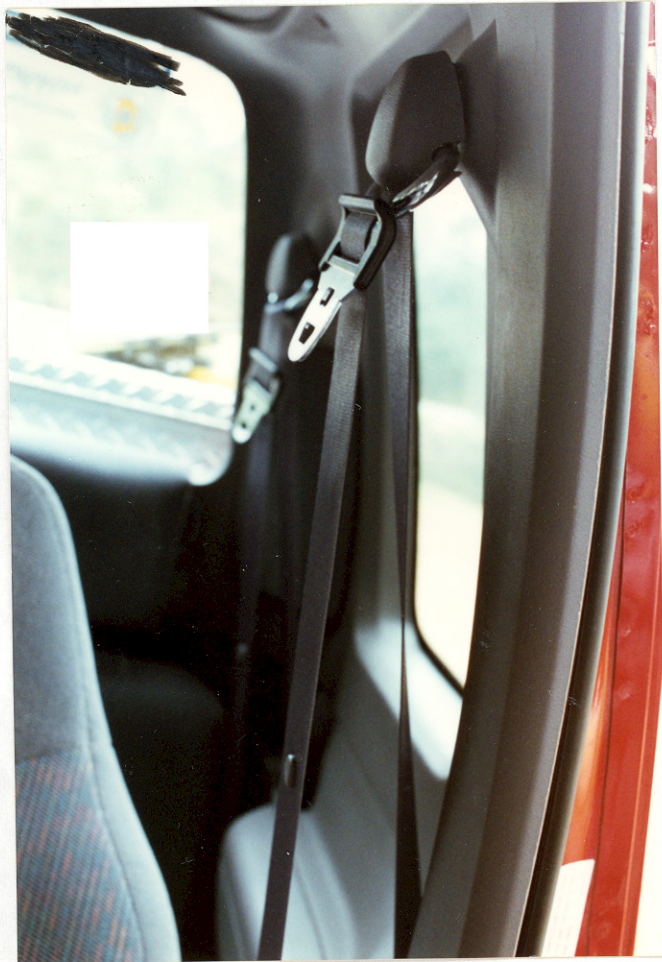
41. Stowed position of the driver's side manual 3-point lap and shoulder belt system.

The belt webbing was in new condition with no evidence of occupant loading or transfers from the air bag module cover flaps or bag fabric. Based on the interior contact points within the vehicle and the lack of loading evidence on the belt system, it was determined that the driver was not wearing the manual restraint system at the time of the crash. Family members stated that the driver was a dedicated belt user, however, they confirmed the lack of belt usage during this crash by the driver at a discussion which transpired following the vehicle inspection. They noted that the driver had undergone gallbladder surgery on [REDACTED] 1994, and that the surgery produced abdominal discomfort. In addition, the discomfort was enhanced by the manual seat belt in the pickup truck. The driver was involved in a severe head-on crash with a similar 1994 Ford F-150 pickup truck on [REDACTED], 1994. He was not belted during that crash and attributed his injury mitigation to the driver's side air bag which deployed. The involved pickup truck was considered a total loss by the insurance company, therefore the driver replaced the vehicle with this accident involved F-150 pickup truck. The family members noted that the abdominal discomfort persisted throughout the month of this accident and that the driver refrained from using the manual belt system to alleviate the discomfort while driving.

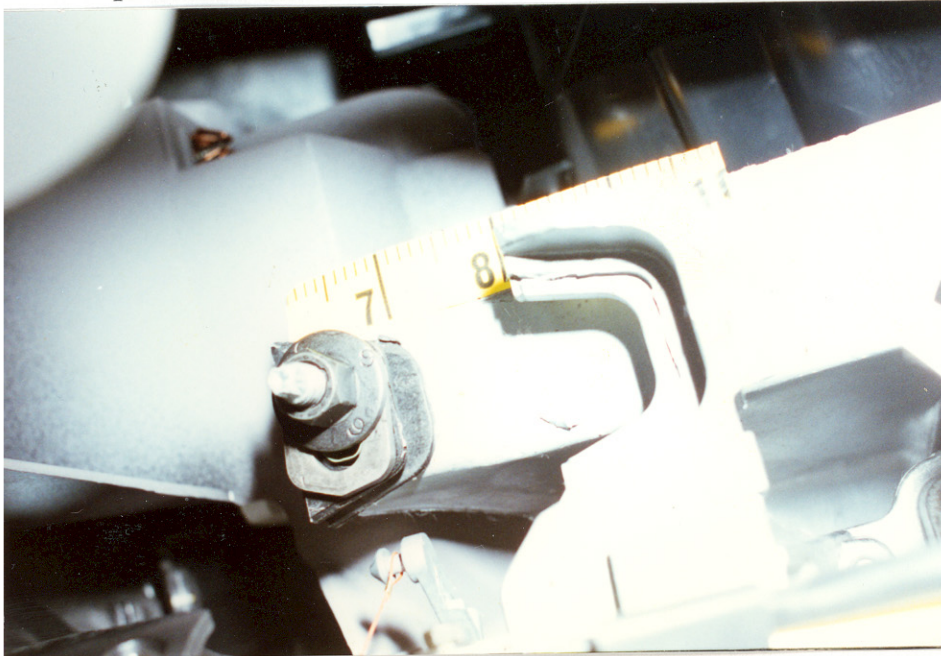
42. Compression of the right side steering column shear capsule.

The driver's forward trajectory, in combination with the expansion of the air bag between the driver and the steering wheel, compressed the energy absorbing steering column approximately 5.70 cm (2.25"). The left alloy shear bracket was displaced 0.9 cm (0.4") forward and subsequently fractured as the column was driven forward. The separation between the fracture points was 4.8 cm (1.9"). The right shear bracket remained intact and had separated 5.3 cm (2.1") from the fixed shear block. At the base of the steering column was a deformable bracket which was displaced forward

The driver's loading force against the steering assembly and the air bag module, in combination with the deploying air bag expanding against his chest, produced compression of the energy absorbing steering column. The deformable bracket of the energy absorbing column was displaced 4.4 cm (1.75") forward. Compression of the steering column resulted in complete separation of the shear capsules. The left side alloy bracket fractured and the right had separated 5.4 cm (2.1").

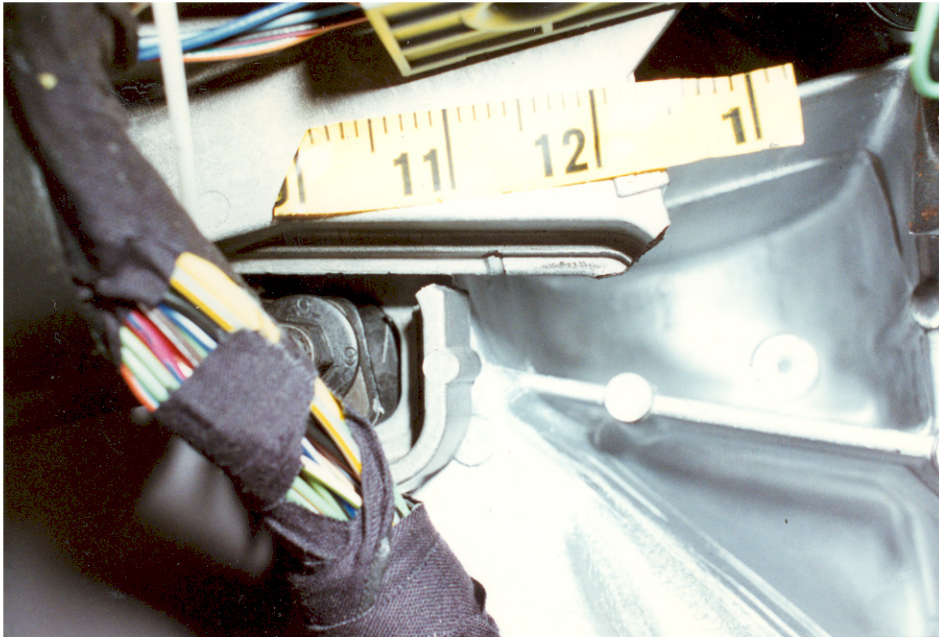
43. Fractured left side shear capsule alloy bracket.

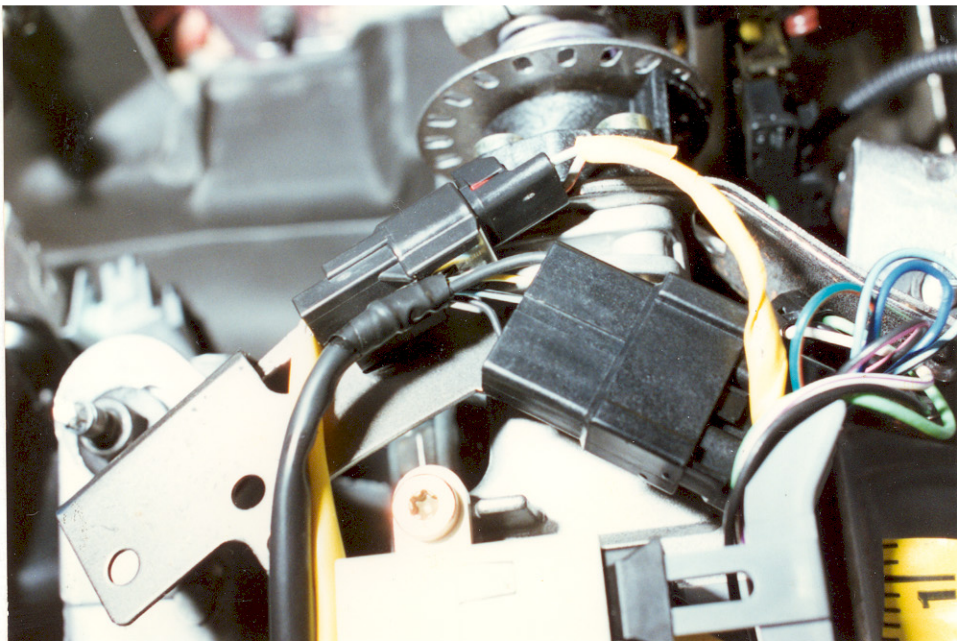
44. Deformable bracket at the base of the energy absorbing steering column.

approximately 4.5 cm (1.75"). There was no damage or bending to the four spoke steering wheel which indicates that a uniform loading force was applied to the wheel. This is consistent with the loading pattern from the bag against the steering wheel spokes and the wide area of injury to the driver which extended from the umbilicus to the underside of the chin. The driver's knees contacted and scuffed the knee bolster on each side of the steering column. No injury resulted to the knees from the bolster contact.

The driver was positioned against or within a close proximity of the air bag module as the SRS deployed. His loading force in response to the frontal impact sequence and the subsequent expansion of the air bag between the driver and the steering assembly resulted in compression of the energy absorbing steering column. The left side shear bracket was displaced 0.95 cm (0.375") forward, however, the alloy shear bracket fractured as the column continued forward. The right shear bracket remained intact and disengaged 5.4 cm (2.125") from the block. The energy absorbing steering column consisted of a deformable bracket that was identified by the following Ford Part No.: [REDACTED]

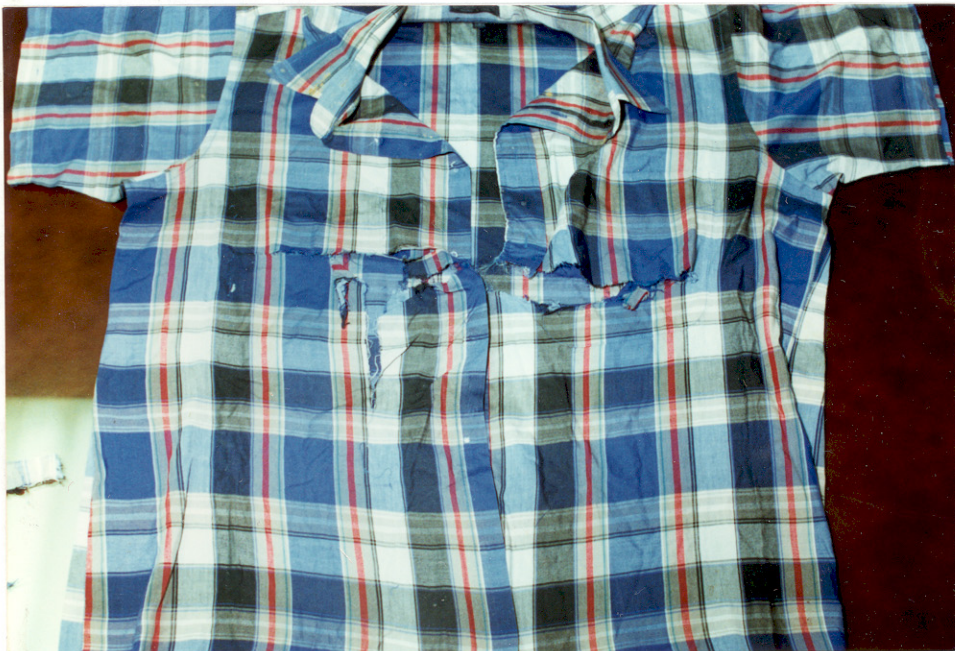
48. Horizontal tear across the chest area of the driver's shirt.

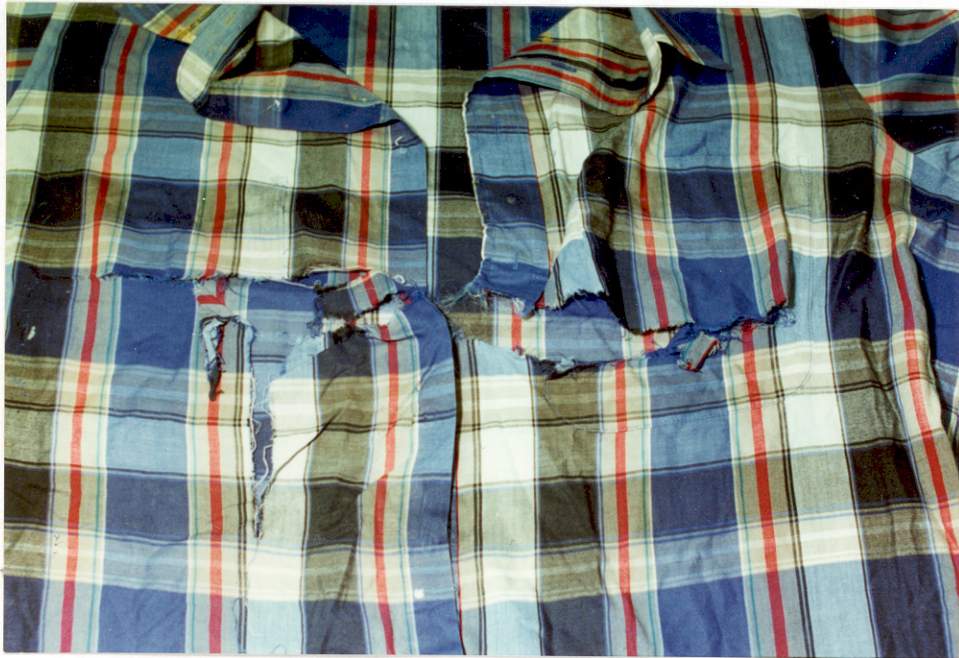
49. Close-up view of the tear pattern.

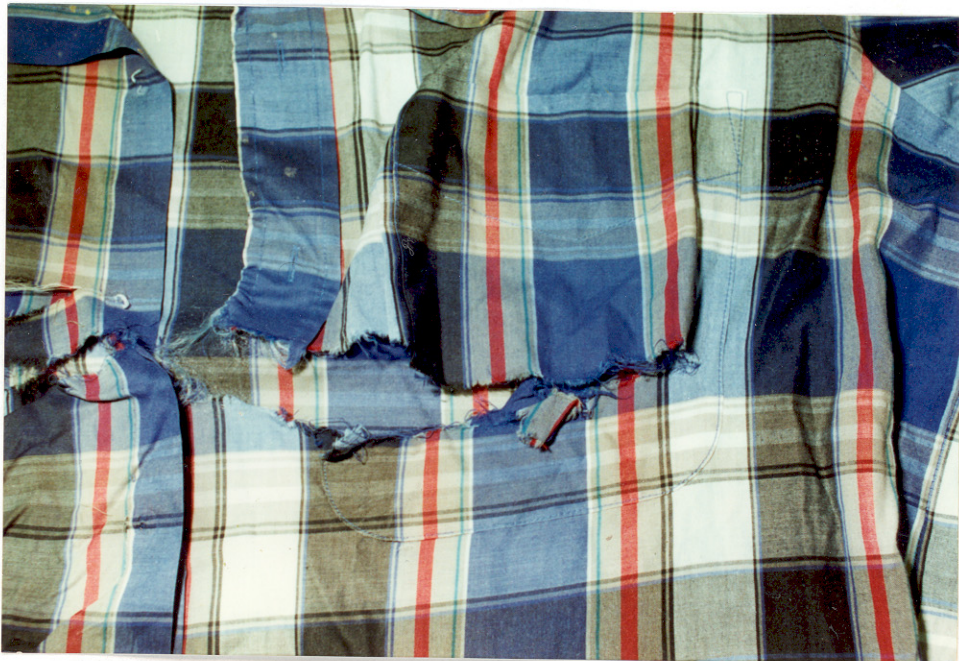
50. Tear across the left pocket.

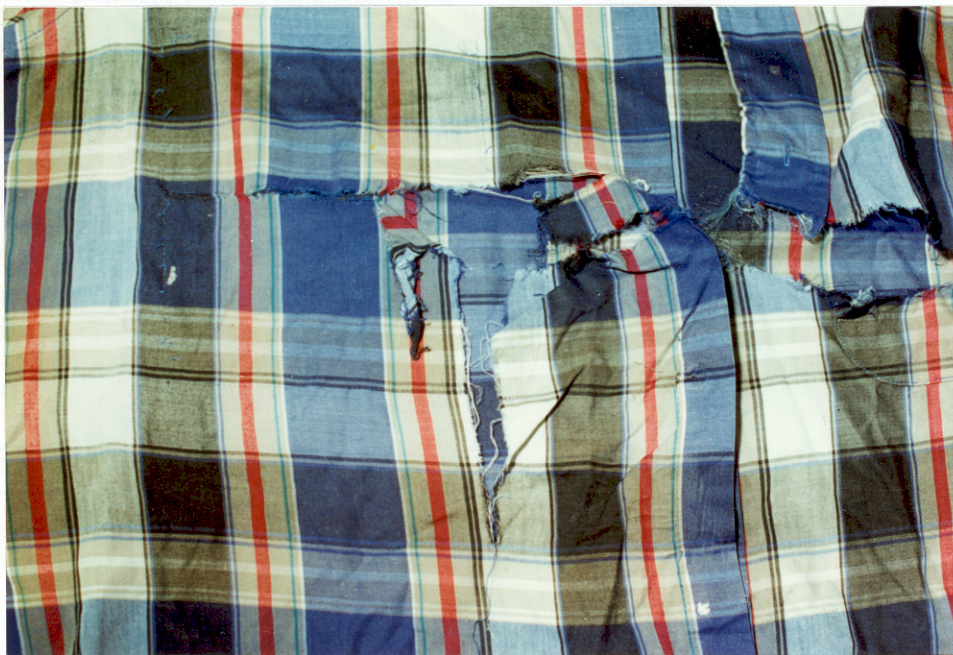
51. Tear across the right pocket area.

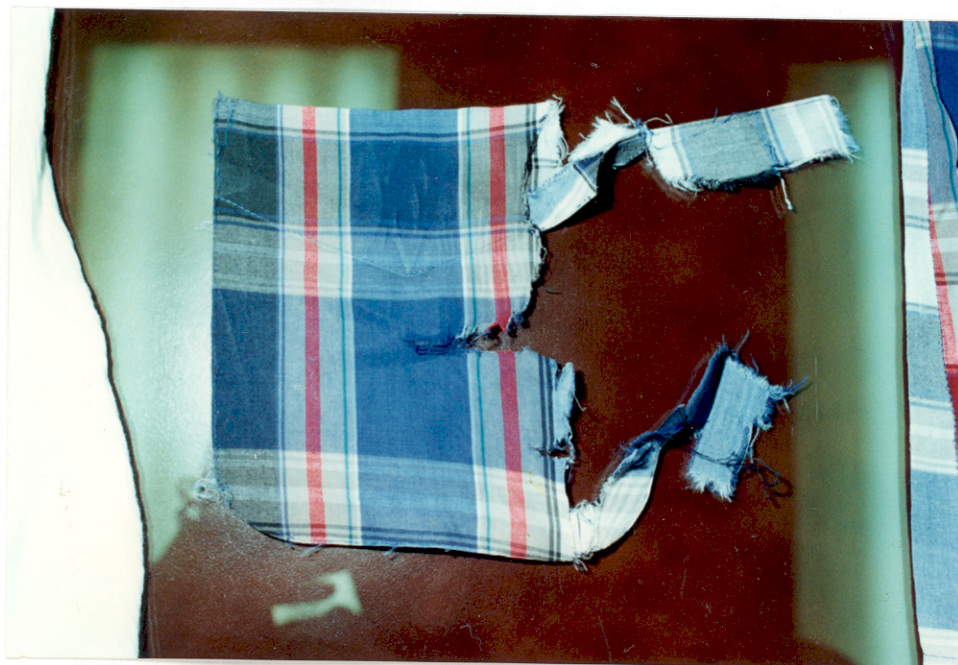
52. Separated right shirt pocket.

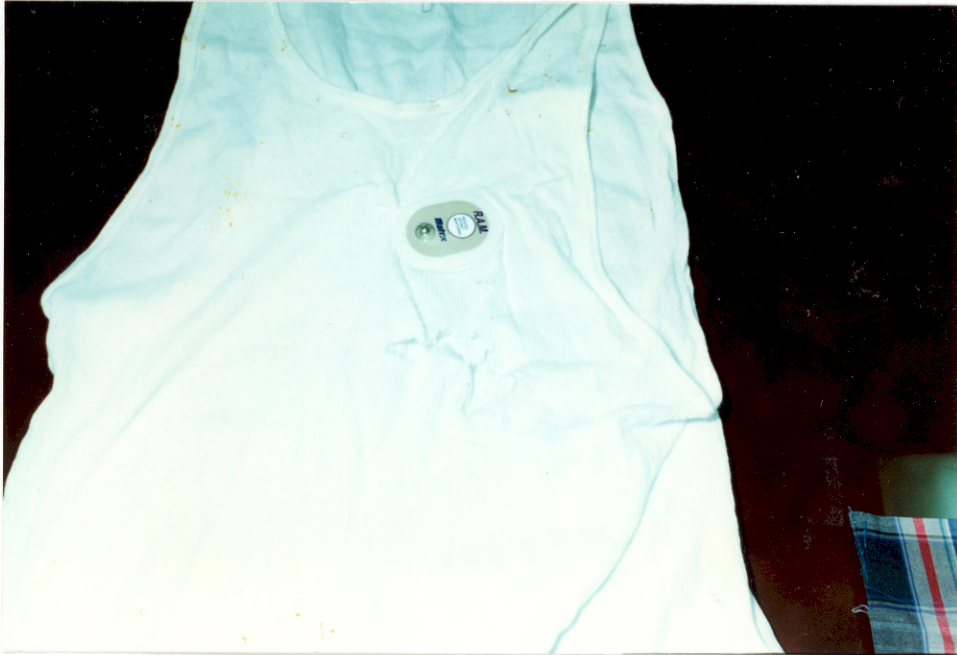
53. Tear of the driver's T-shirt at the left chest area.

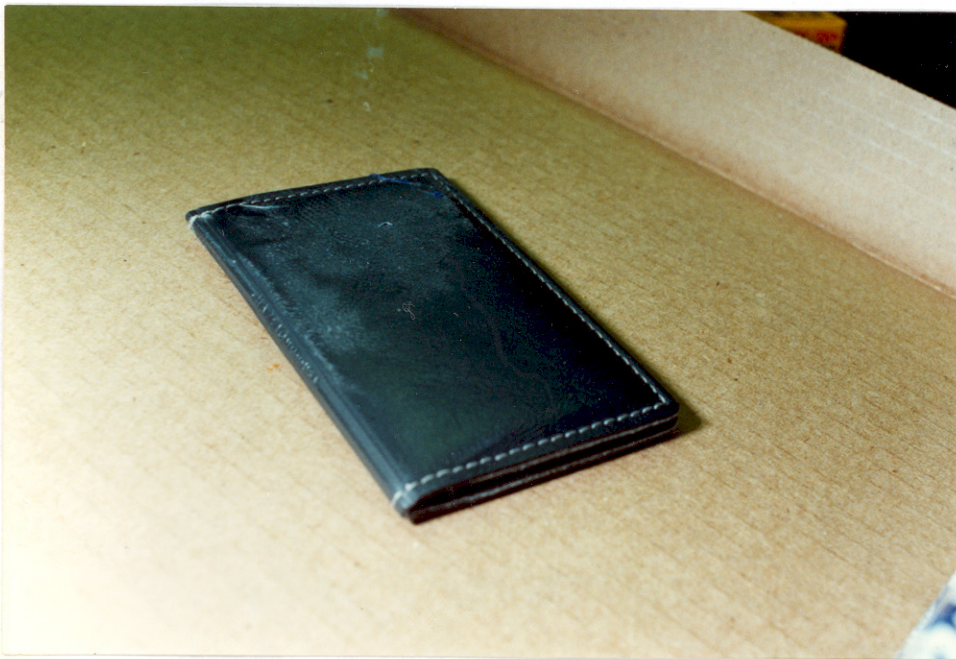
54. Air bag fabric transfers on the leather pocket calendar contained in the driver's shirt pocket.

transferred on the air bag at the 6 o'clock sector (refer to Photograph No. 24). In addition to the shirt damage, the driver had a leather bound pocket calendar in one of the shirt pockets. The side of the leather calendar that was exposed to the air bag had a white transfer from the air bag fabric that was both patterned and irregular (refer to Photograph Nos. 54 and 55 of Attachment B). Fabric fibers from the driver's plaid shirt were embedded into the leather calendar in the area of the air bag transfer. The driver's T-shirt was also torn in an irregular pattern over the left chest area.

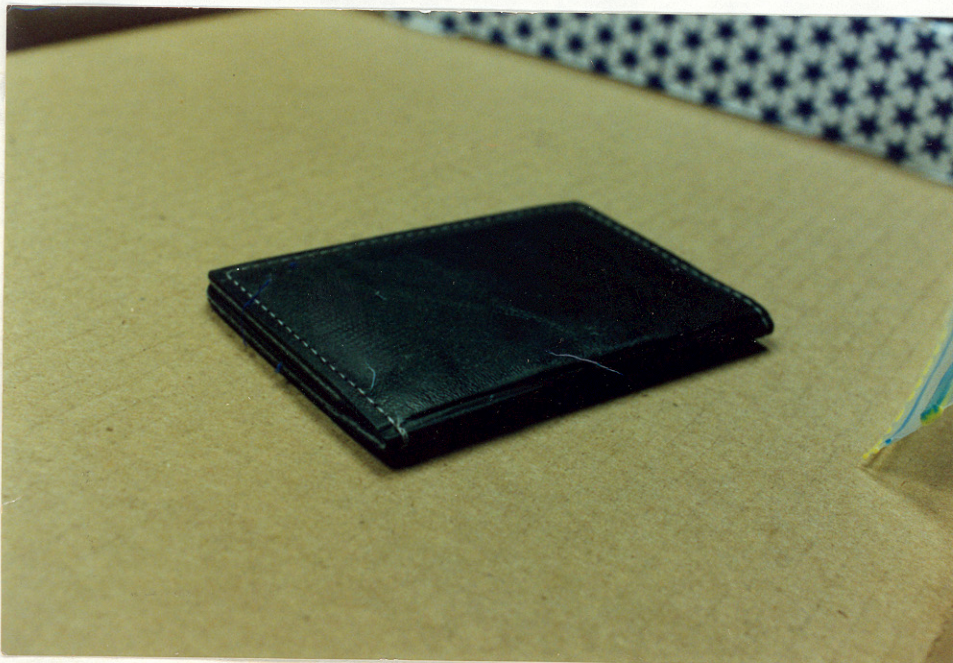
55. Additional view of the fabric transfer on the pocket calendar.

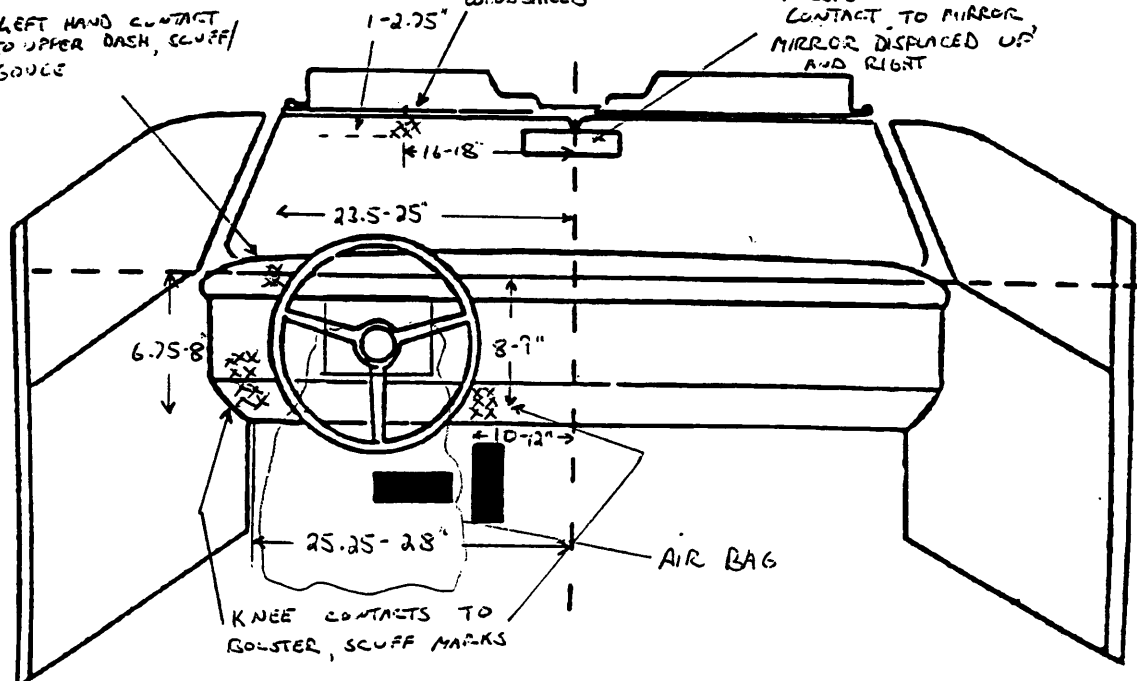
THORACIC COLLISION  
OF COLUMN, 2.125"  
OF SHEAR SEPARATIONLEFT HAND CONTACT  
TO UPPER DASH, SCUFF/  
GOUGEHEAD CONTACT TO  
HEADER TRIM (DENT),  
AND DIRT SMUDGE ON  
WINDSHIELDPOSSIBLE RIGHT HAND  
CONTACT TO MIRROR  
MIRROR DISPLACED UP  
AND RIGHT

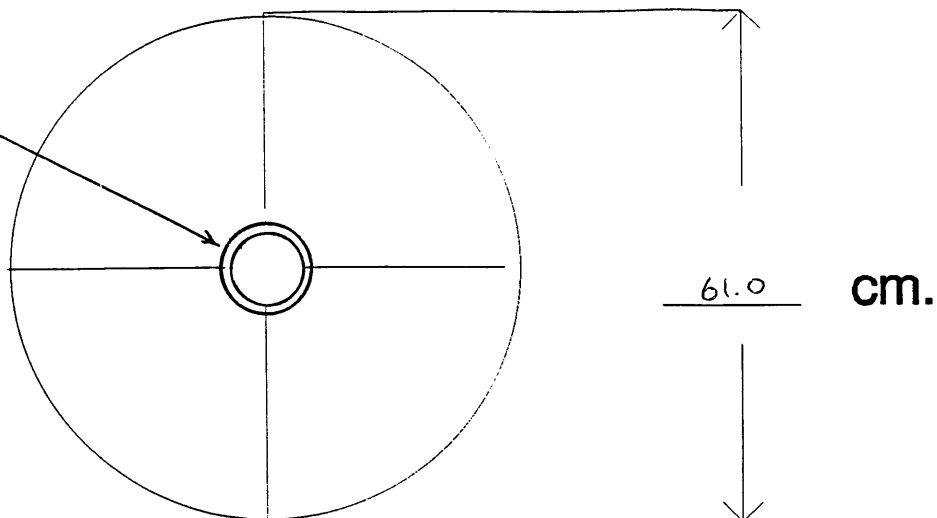
## 1. SKETCH DAMAGE AND CONTACT EVIDENCE ON DRIVER AIR BAG (Front)

2 ROWS OF STITCHING  
FOR TETHER  
REINFORCEMENT  
16.5 cm (6.5")  
DIAMETER
